MODEL A-30 ALTITUDE ENCODER AND MODEL E-01 ELT CONTINUING AIRWORTHINESS REQUIREMENTS

Service Bulletin SB E-01.3

Service bulletin SB E-01.6

SERVICE BULLETIN SB E-01.9 December 12, 2006 MODEL E-01 ELT AFFECTS ALL SERIAL NUMBERS

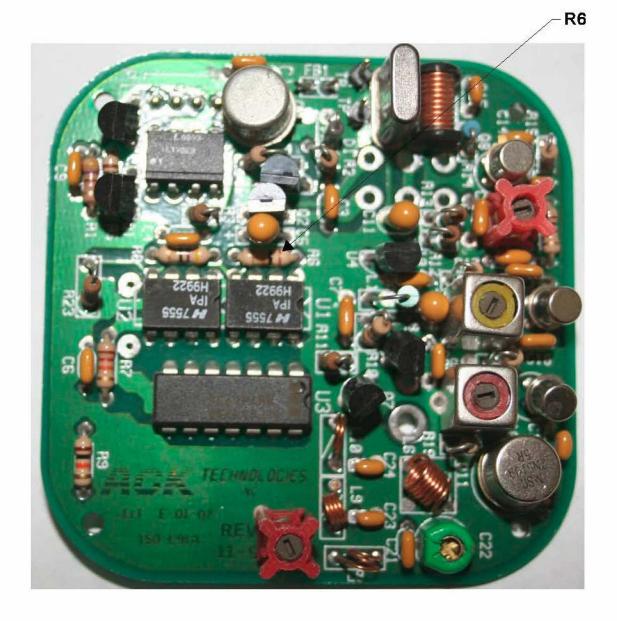
The acceptable sweep rate for the model E-01 ELT is 2 to 4 Hz. If the sweep rate falls below the 2 Hz rate replace resistor R6 with a 80 ohm resistor and re-test.
